**Elyria Foundry:** Learn how spray foam was used to divert water from 4 different directions

**Project Overview:** Spray foam roofing over existing smooth modified bitumen and wood sheeting

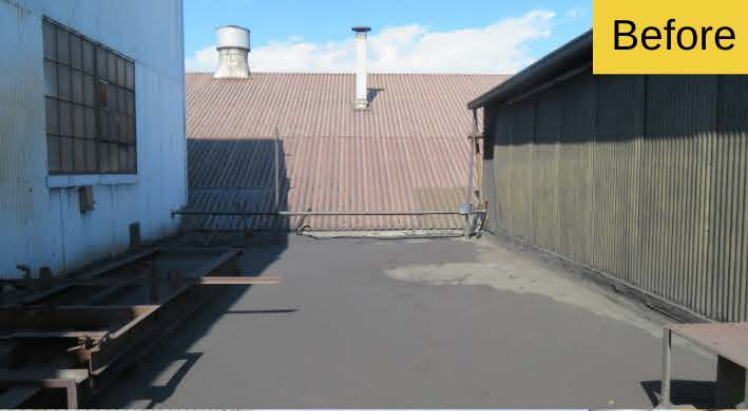
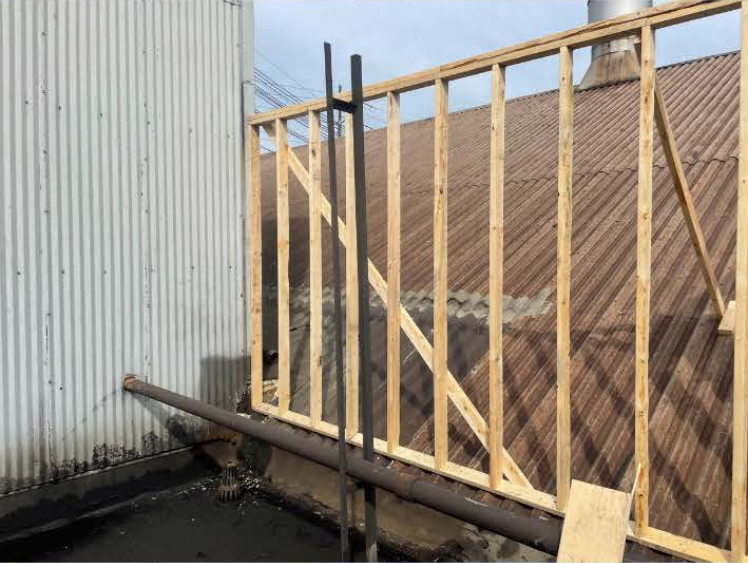
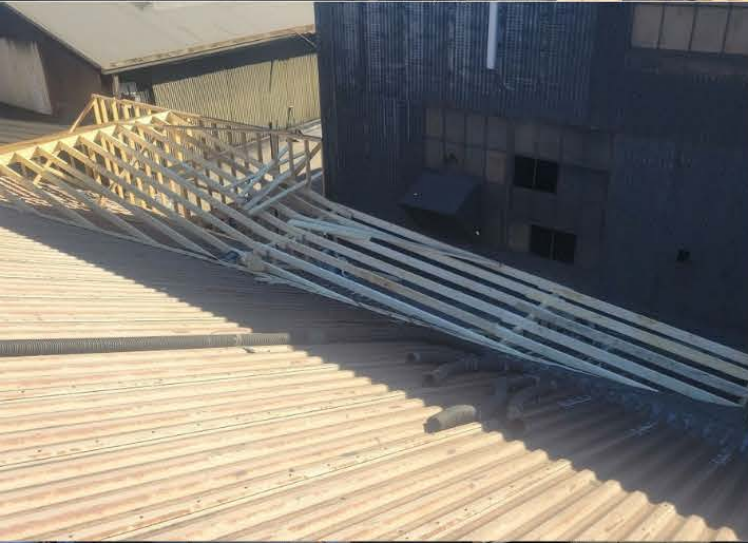
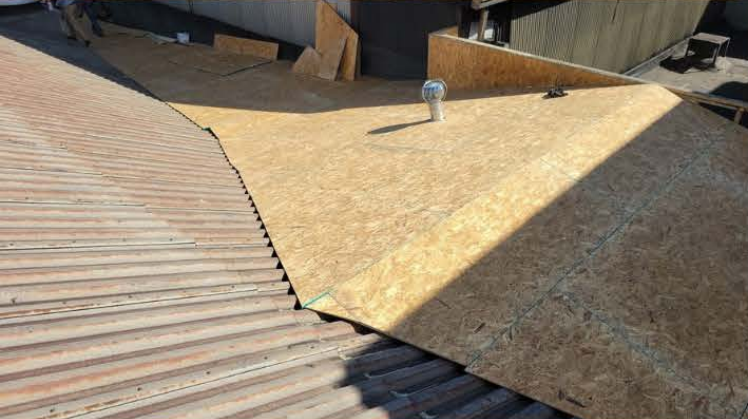
Before

**This was the main problem of this project: The additional buildings created a "pit."** The pit was receiving water from four roof sections. With only two drains and the amount of sand that escaped through the building, the drains quickly clogged. This created standing water in the "feet," which allowed water to enter the building.

To eliminate this problem, we rerouted four waterways with new downspouts, new gutters, building a wall, and a dormer. To custom make a 12-foot wall, build a custom-fit dormer with custom sloping out of wood, and foam it all in is something innovative and creative.

The pit, surrounding walls, the new wall, and the dormer all received spray foam, coating, and granules.

- Deck replacement in "the pit", hot permit needed to cut into metal.
- Redirect over 45 feet of downspouts to run away from the pit.
- 12 ft. wall built, dormer attached, 100% foamed and coated, seamless attachment to existing roof
- New metalwork was custom created to heighten the channels of existing gutters that backed up
